SOUTHEAST HOME INSPECTION REPORT

On _____, a visual inspection of the property located at
_____ Clarksville Tennessee 37042. _____

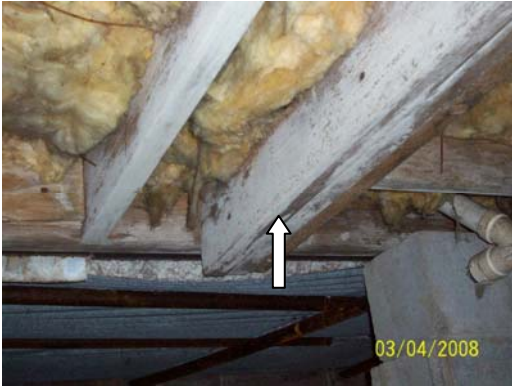
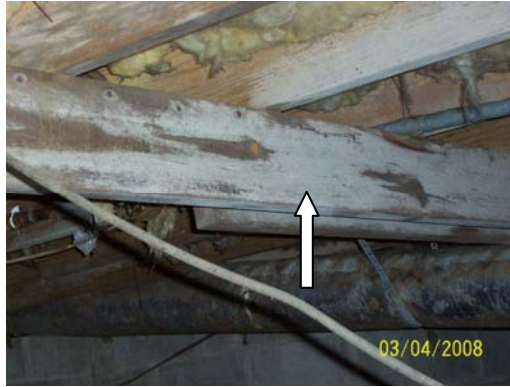
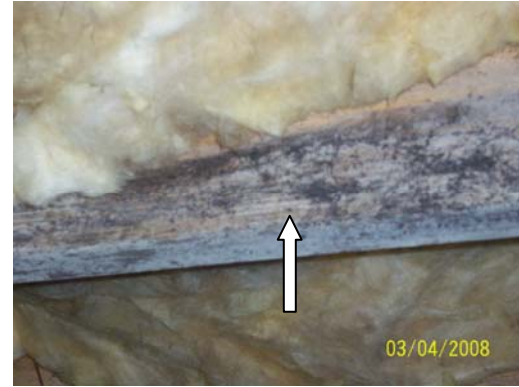
2. Crawlspace interior wood flooring members showing evidence of fungal growth, this fungal growth is most likely due to a heavy moisture presence in the crawlspace interiors and will need to be further evaluated by a licensed moisture control contractor to determine required treatment and repairs. (PHOTO PAGE 5a)

Crawlspace interior wood flooring members showing evidence of fungal growth, this fungal growth is most likely due to a heavy moisture presence in the crawlspace interiors and will need to be further evaluated by a licensed moisture control contractor to determine required treatment and repairs. (PHOTO PAGE 5a)

Crawlspace interior wood flooring members with fungal growth

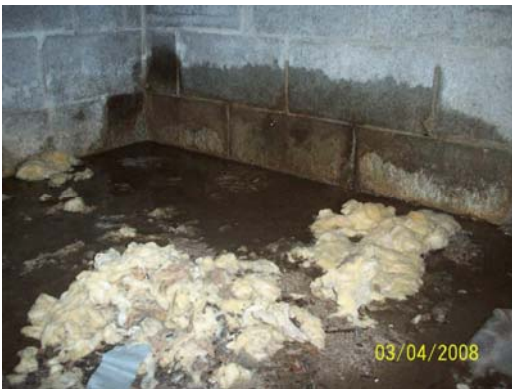
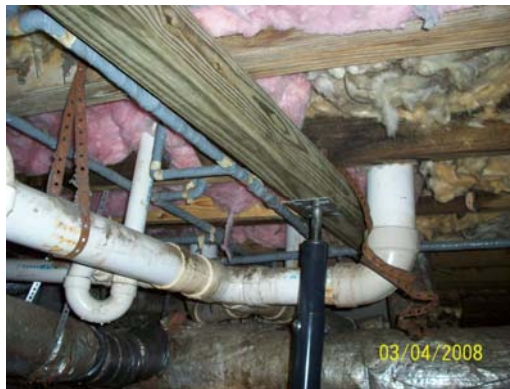
3. Crawlspace interior front left corner showing evidence of standing water with water penetration observed flowing through the foundation wall concrete mortar joints. This standing water appears to have two contributing factors to include: (1) front left gutter downspout improperly exiting at or near the foundation wall and (2) heavily saturated soils at the time of inspection. Front left gutter downspout plastic splash block does not appear to have sufficient slope to carry rain water away from the foundation wall. The roof water then ponds at the foundation wall absorbs into the ground and seeps into the crawlspace interior. Crawlspace interior will need to further evaluated by a licensed structural water proofing contractor to determine required repairs. (PHOTO PAGE 5a)

Crawlspace interior front left corner showing evidence of standing water with water penetration observed flowing through the foundation wall concrete mortar joints. This standing water appears to have two contributing factors to include: (1) front left gutter downspout improperly exiting at or near the foundation wall and (2) heavily saturated soils at the time of inspection. Front left gutter downspout plastic splash block does not appear to have sufficient slope to carry rain water away from the foundation wall. The roof water then ponds at the foundation wall absorbs into the ground and seeps into the crawlspace interior. Crawlspace interior will need to further evaluated by a licensed structural water proofing contractor to determine required repairs. (PHOTO PAGE 5a)

Crawlspace interior front left corner with standing water

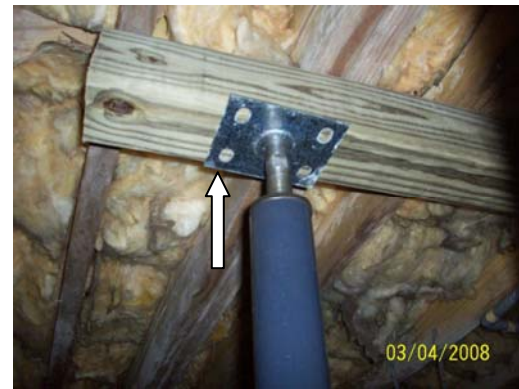
4. Crawlspace interior showing evidence of additional support posts with 4 X 4 beam located beneath the interior bathroom, this additional support appears to be sitting directly on the earth floor and is improperly installed. A further evaluation by a licensed structural contractor will be needed to determine proper repairs. (PHOTO PAGE 5a)

Crawlspace interior showing evidence of additional support posts with 4 X 4 beam located beneath the interior bathroom, this additional support appears to be sitting directly on the earth floor and is improperly installed. A further evaluation by a licensed structural contractor will be needed to determine proper repairs. (PHOTO PAGE 5a)

Additional support posts and 4 X 4 beam improperly installed

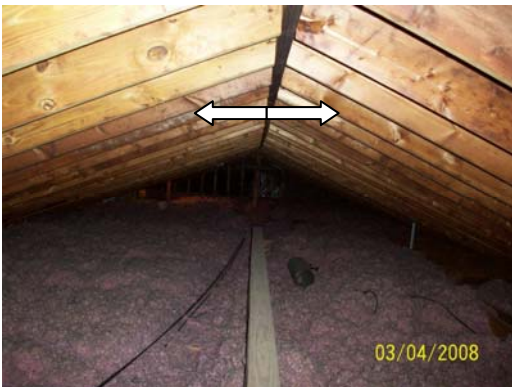
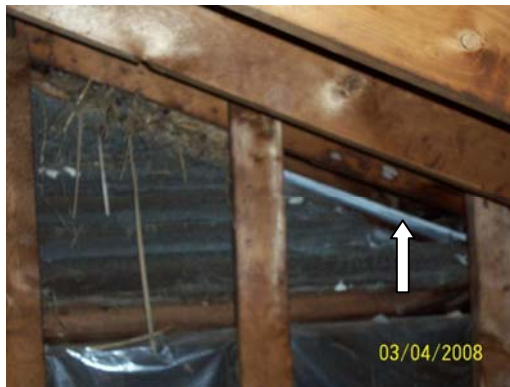
5. Attic interior roof structure showing evidence of uninstalled collar ties, these wood beams will need to be installed horizontally across the roof rafters to provide additional roof support. (PHOTO PAGE 5a)

Attic roof structure with missing collar ties

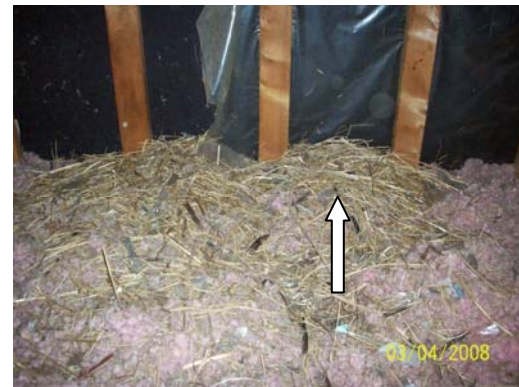
6. Attic interior left side gable vent showing evidence of damaged screening with active animal nesting. All nesting will need to be removed and metal screening repaired or replaced to prevent further animal intrusion to the attic interior spaces. (PHOTO PAGE 5a)

Attic interior left side gable vent showing evidence of damaged screening with active animal _____ nesting. All nesting will need to be removed and metal screening repaired or replaced to prevent further animal intrusion to the attic interior spaces. (PHOTO PAGE 5a) _____

Left side attic gable vent with damaged screening and animal nesting

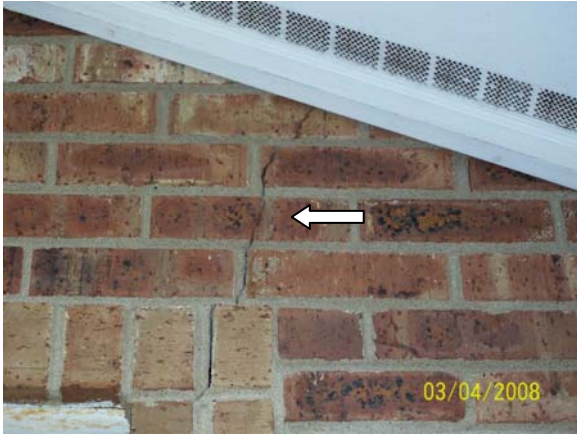
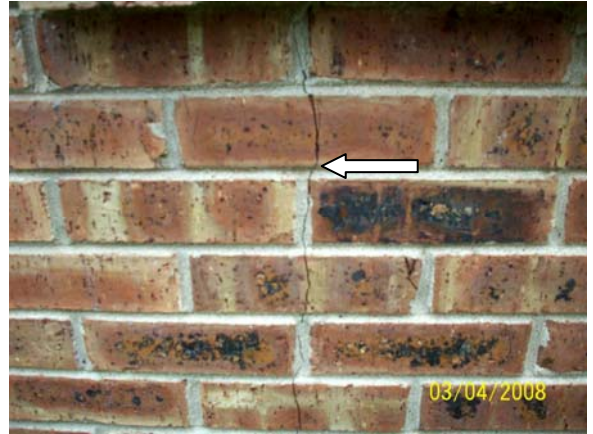
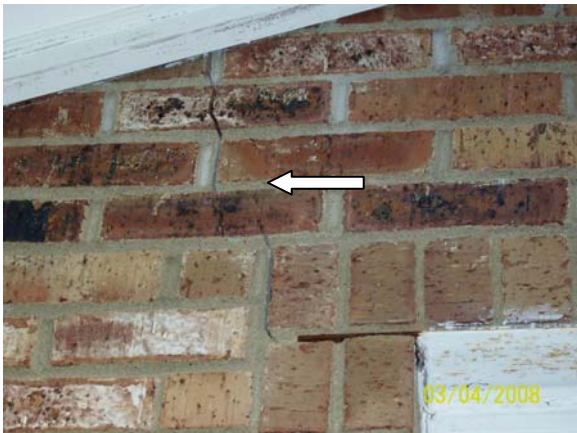
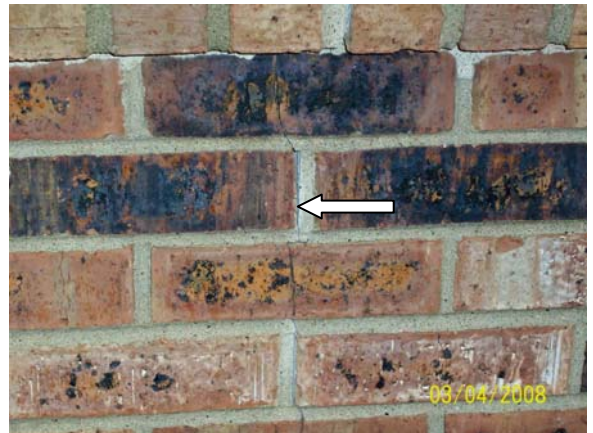
12. Exterior masonry siding showing evidence of vertical cracking, this cracking condition is most likely due to warping steel lintels and will need to be further evaluated by a licensed masonry contractor to determine required repairs.(PHOTO PAGE 6a)

Exterior masonry siding showing evidence of vertical cracking, this cracking condition is most likely due to warping steel lintels and will need to be further evaluated by a licensed masonry contractor to determine required repairs. (PHOTO PAGE 6a)

Exterior masonry siding with evidence of vertical and step cracking

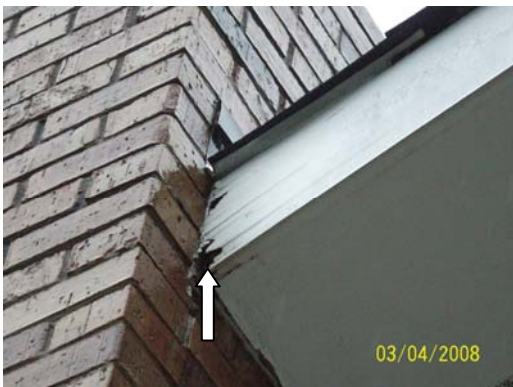
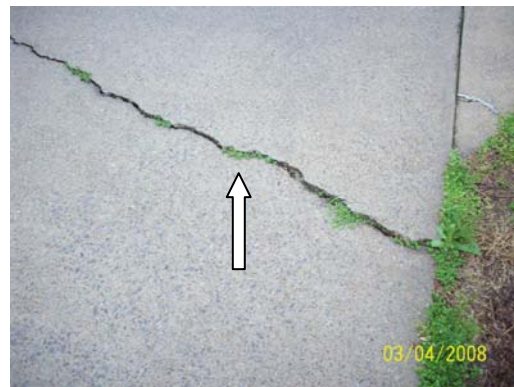
13. Left side exterior wood fascia trim located near the chimney housing showing evidence of rot and deterioration and will need to be removed and replaced with new wood caulked and painted to prevent further deterioration.(PHOTO PAGE 6a)

Left side exterior wood fascia trim located near the chimney housing showing evidence of rot and deterioration and will need to be removed and replaced with new wood caulked and painted to prevent further deterioration. (PHOTO PAGE 6a)

Exterior wood fascia trim with rot and deterioration

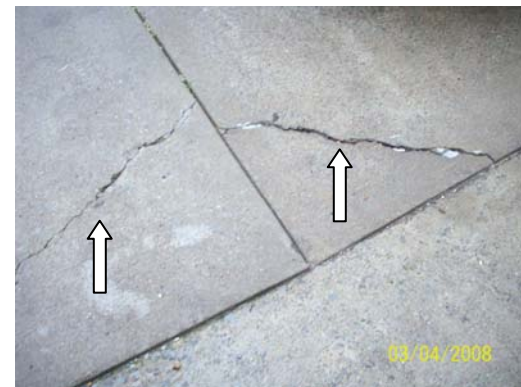
25. Right side concrete driveway showing evidence of cracked and heaved slabs, this cracking and heaving is due to age and typical settlement. Heaved concrete slabs will need to be monitored and further evaluated by a licensed paving contractor to reduce the risk of tripping hazard. (PHOTO PAGE 6a)

Right side concrete driveway showing evidence of cracked and heaved slabs, this cracking and heaving is due to age and typical settlement. Heaved concrete slabs will need to be monitored and further evaluated by a licensed paving contractor to reduce the risk of tripping hazard. (PHOTO PAGE 6a)

Concrete driveway slabs with typical cracking and heaving

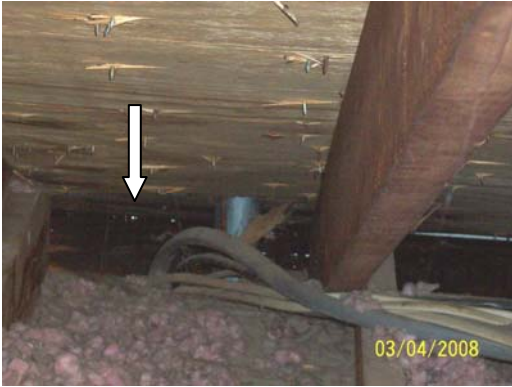
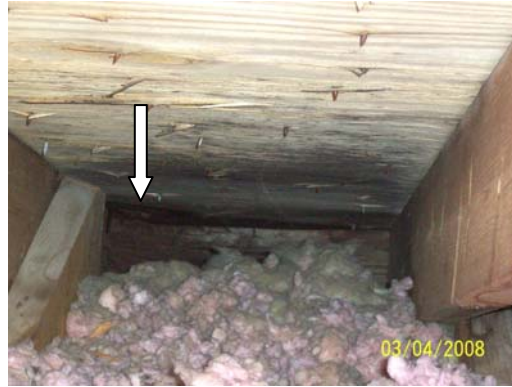
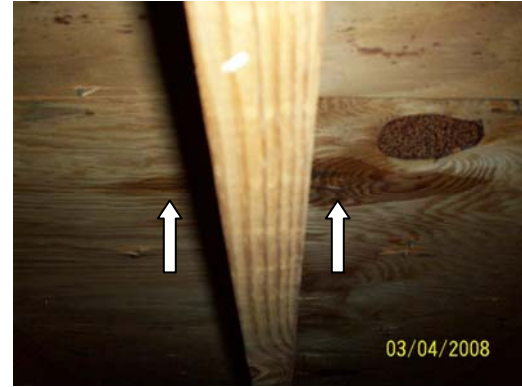
7. Roofing shingles appear to be the 20 year asphalt/fiberglass 3 tab type with evidence of numerous loose shingles. These shingles appear to have come loose at the tar strips indicating wear, age and vulnerability to wind damage. Attic interior roof sheathing showing evidence of deterioration and water penetration near the left side front porch soffit and rear electrical mast. Unable to determine exact age of roofing shingles and according to the manufacturers guidelines and with proper installation 20 year asphalt/fiberglass type roofing shingles can have a life expectancy of 15 to 20 years. All roofing components will need to be further evaluated by a licensed roofing contractor to determine age, source of leakage and repairs.(PHOTO PAGE 7a)

Roofing shingles appear to be the 20 year asphalt/fiberglass 3 tab type with evidence of numerous loose shingles. These shingles appear to have come loose at the tar strips indicating wear, age and vulnerability to wind damage. Attic interior roof sheathing showing evidence of deterioration and water penetration near the left side front porch soffit and rear electrical mast. Unable to determine exact age of roofing shingles and according to the manufacturers guidelines and with proper installation 20 year asphalt/fiberglass type roofing shingles can have a life expectancy of 15 to 20 years. All roofing components will need to be further evaluated by a licensed roofing contractor to determine age, source of leakage and repairs. (PHOTO PAGE 7a)

Roof sheathing with evidences of deterioration and water penetration

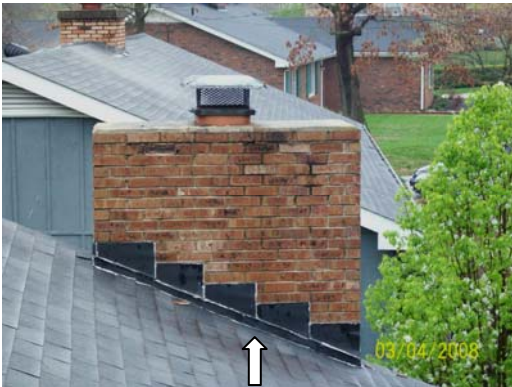
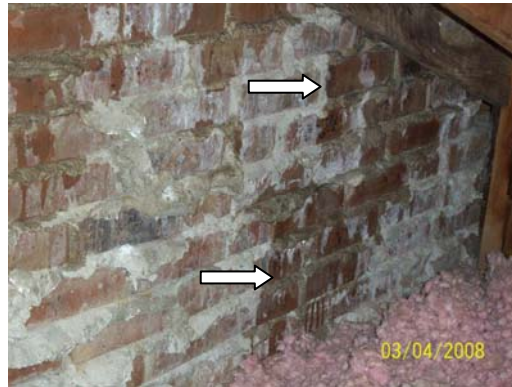
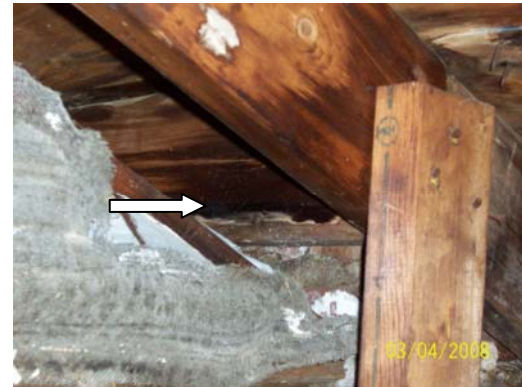
8. Roofing chimney showing evidence of water penetration to the attic interior masonry and wood support members. This water penetration is most likely due to failed metal flashing and counter flashing. Metal flashing will need to be further evaluated and repaired by a licensed roofing contractor to determine required repairs.(PHOTO PAGE 7a)

Roofing chimney showing evidence of water penetration to the attic interior masonry and wood support members. This water penetration is most likely due to failed metal flashing and counter flashing. Metal flashing will need to be further evaluated and repaired by a licensed roofing contractor to determine required repairs. (PHOTO PAGE 7a)

Roof chimney metal flashing leaking into the attic interior

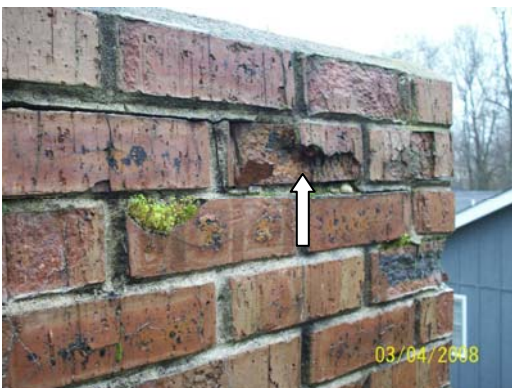
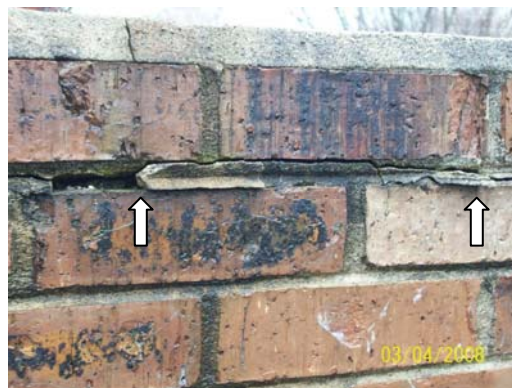
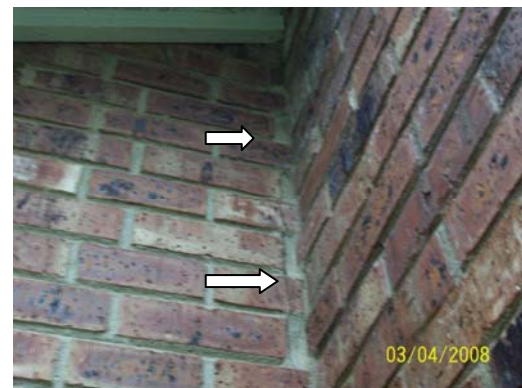
9. Left side masonry chimney showing evidence of spalling, deteriorated concrete mortar joints and cracking to the perimeter masonry siding. Over time moisture penetrates the masonry surface leading to deterioration of the masonry surfaces and concrete mortar joints. The perimeter cracking may be an indication of chimney movement and a further evaluation of the entire chimney housing will be needed by a licensed chimney contractor to determine required repairs.(PHOTO PAGE 7a)

Left side masonry chimney showing evidence of spalling, deteriorated concrete mortar joints and cracking to the perimeter masonry siding. Over time moisture penetrates the masonry surface leading to deterioration of the masonry surfaces and concrete mortar joints. The perimeter cracking may be an indication of chimney movement and a further evaluation of the entire chimney housing will be needed by a licensed chimney contractor to determine required repairs. (PHOTO PAGE 7a)

Roof chimney with spalling, deteriorated mortar joints and perimeter cracking

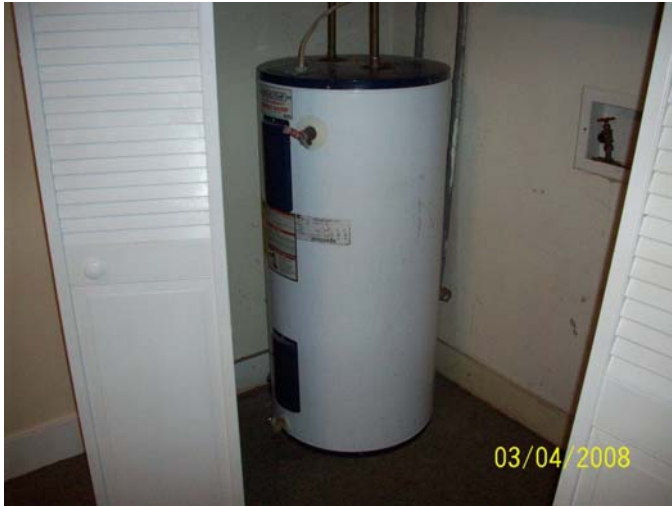
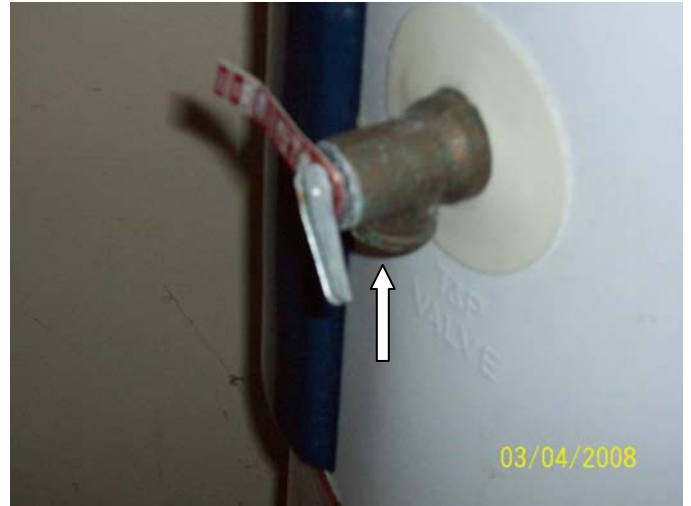
16. Electric water heating unit showing evidence of missing relief valve extension tube and overflow pan. Overflow pan will need to be installed under unit and plastic PVC or copper extension tube will need to be installed by a license plumbing contractor. (PHOTO PAGE 8a)

Electric water heating unit showing evidence of missing relief valve extension tube and overflow pan. Overflow pan will need to be installed under unit and plastic PVC or copper extension tube will need to be installed by a license plumbing contractor. (PHOTO PAGE 8a)

Electric water heating unit approximately 10 years of age with missing plastic PVC or copper relief valve extension tube

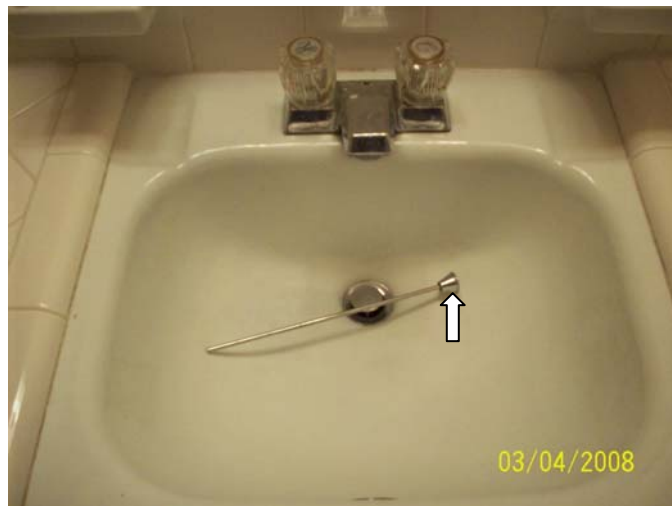
17. Interior hallway bathroom sink basin showing evidence of damaged drain stopper hardware and in need of repair by a licensed plumbing contractor to restore intended function. (PHOTO PAGE 8a)

Interior hallway bathroom sink basin showing evidence of damaged drain stopper hardware and in need of repair by a licensed plumbing contractor to restore intended function. (PHOTO PAGE 8a)

Hallway bathroom with damaged drain stopper hardware

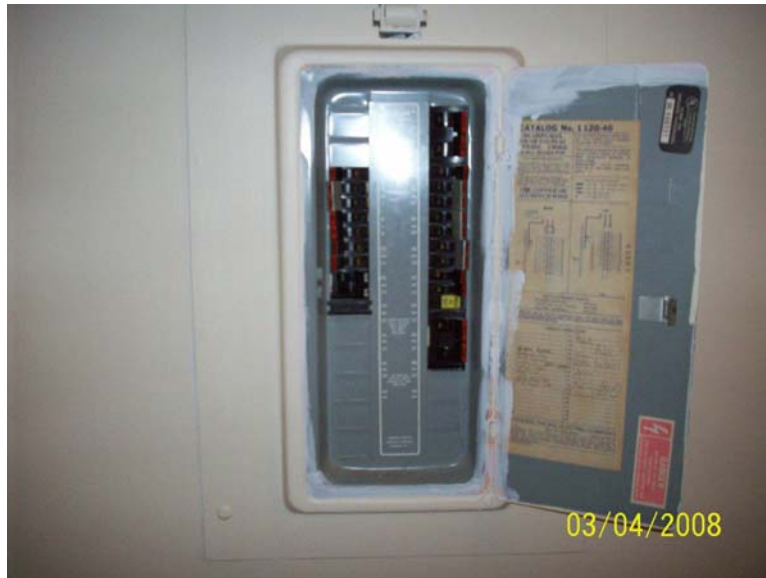
1. 200 amp electrical service panel located in converted garage is the Federal Pacific "stab-Loc" type, these electrical panels have a history of the circuit breakers failing to "trip" in an over-current condition leading to possible electrical fires. The breakers have also been known to not shut off when the switch is in the "tripped" position. These panels have also been known to have additional concerns such as panel and panel bus fires and arching failures in some equipment. Replacement breakers can be purchased and replaced and electrical panel will need to be further evaluated by a licensed electrician to certify panel.

Federal pacific stab-Lok main service panel

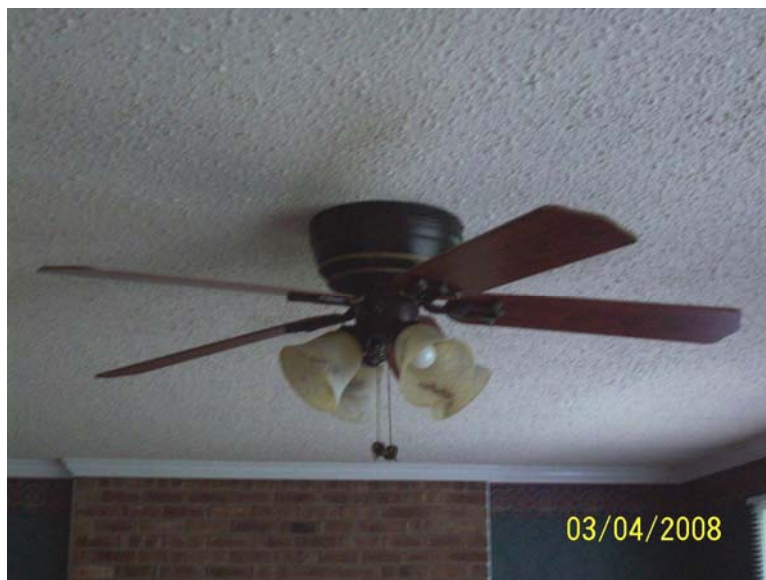
24. Living room interior ceiling fan not functional and will need to be repaired or replaced by a licensed contractor to restore intended function. (PHOTO PAGE 9a)

Living room ceiling fan not functional

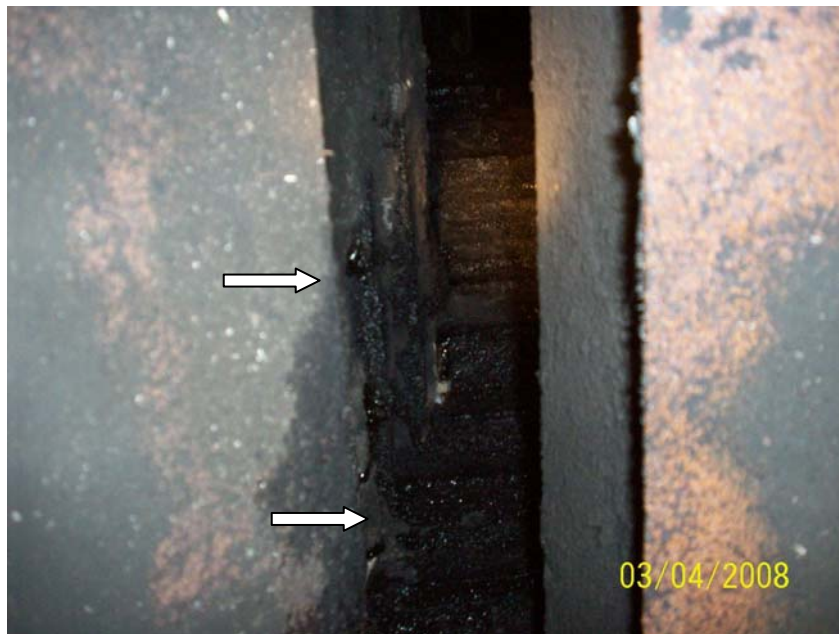
14. Wood burning fireplace showing evidence of minimal ponding water on the firebox floor, this leakage appears to be originating just below the clay flue and will need to be further evaluated by a licensed chimney repair contractor.(PHOTO PAGE 10a)

Interior chimney with water penetration located beneath the flue

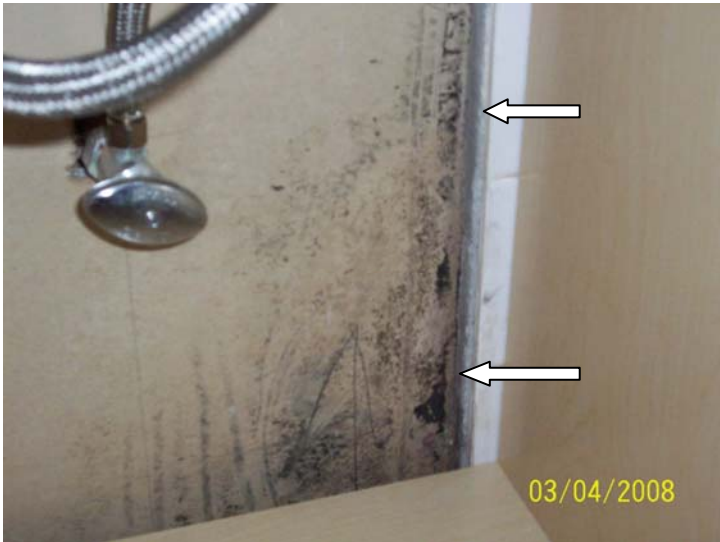
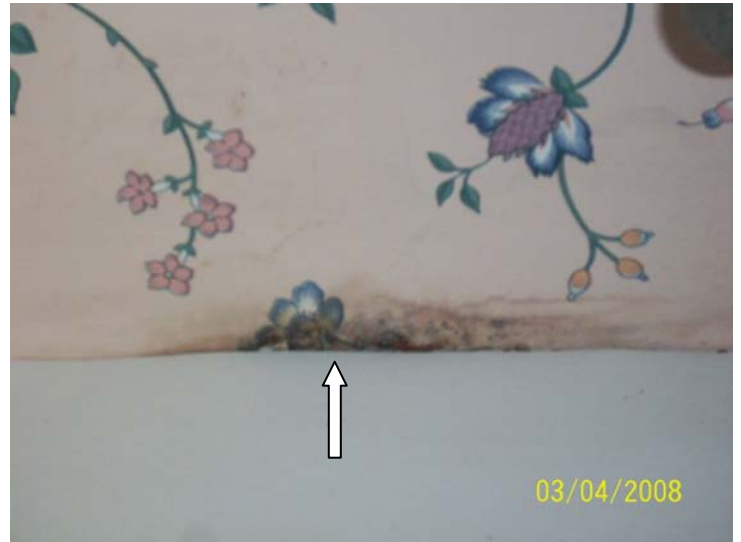
20. Interior master and hallway bathroom showing evidence of fungal growth located on the wall board located beneath the sink basins. All interior wall board with fungal growth will need to be removed and replaced. All wood framing members will need to be evaluated to ensure fungal growth has not penetrated wood members. (PHOTO PAGE 12a)

Interior master and hallway bathrooms with fungal growth on wall board located beneath sink basin

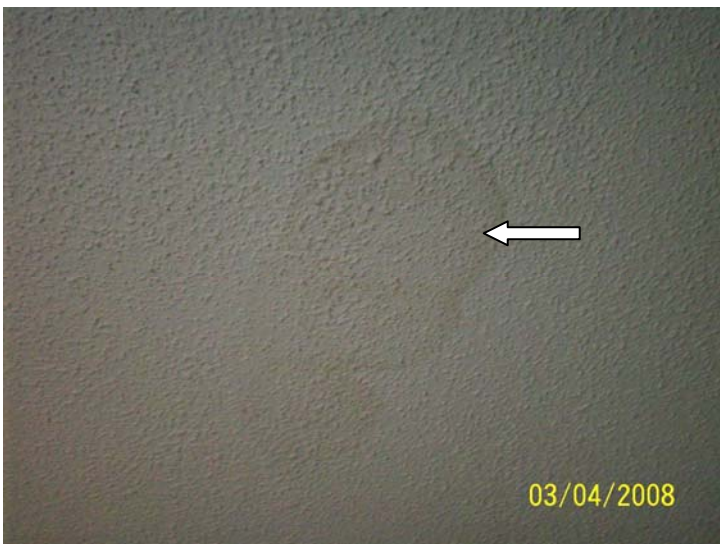
21. Interior converted garage family room ceiling showing evidence of past or present water staining, area will need to be painted with a "KILZ" material to prevent stain from reoccurring. (PHOTO PAGE 12a)

Interior family room with evidence of past or present water staining

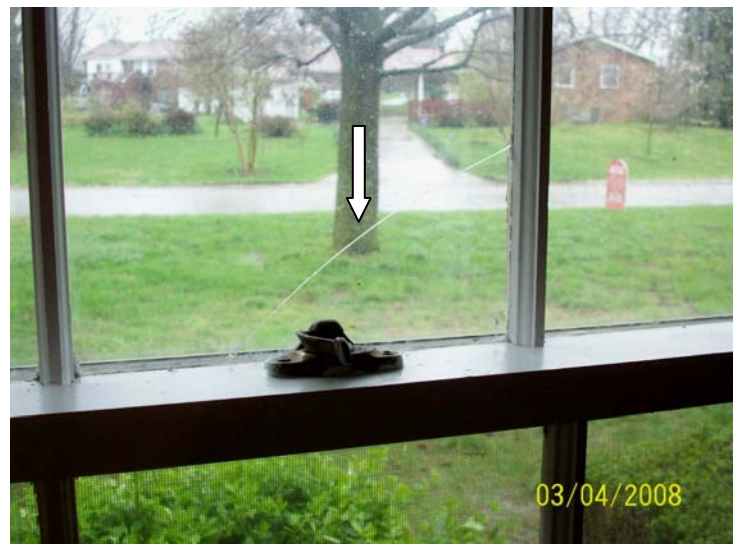
22. Living room interior window showing evidence of glass damage and in need of replacement to prevent possible injury and as a safety concern. (PHOTO PAGE 12a)

Interior living room window with glass damage

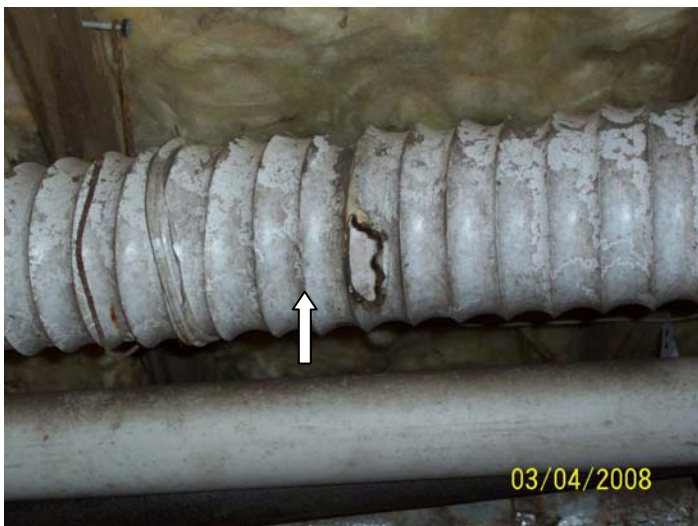
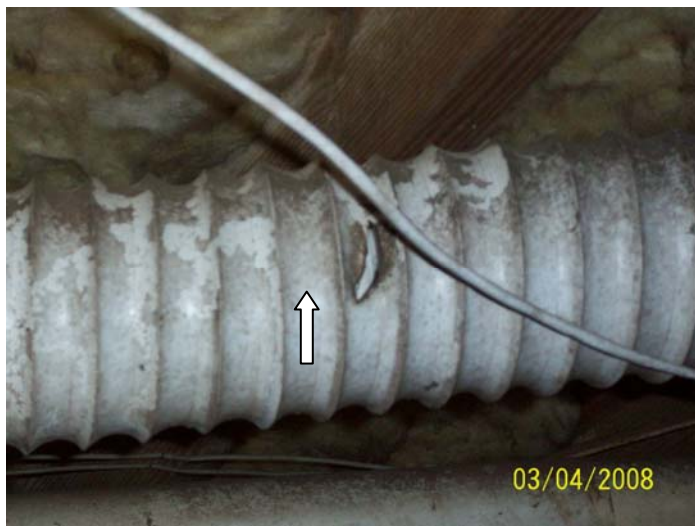
18. Flexible dryer exhaust tube showing evidence of previous repairs with wear and deterioration, flexible exhaust tube will need to be removed and replaced to prevent further lint accumulation to the crawlspace interior. (PHOTO PAGE 13a)

Crawlspace interior dryer exhaust hose worn and deteriorated

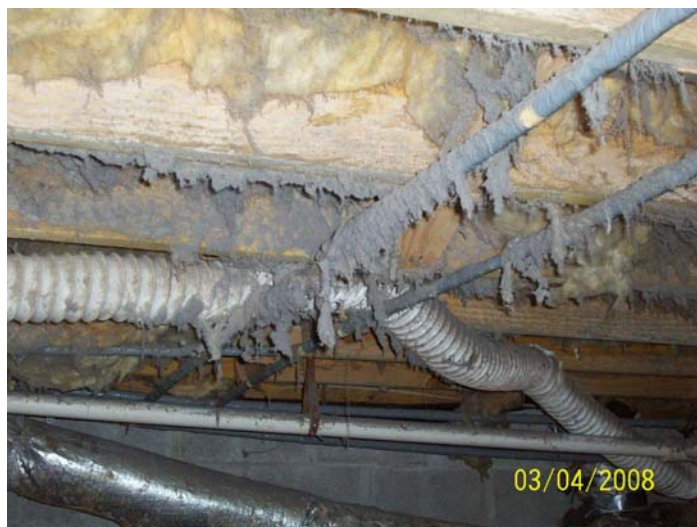
19. Crawlspace interior wood flooring members showing evidence of excess dryer lint, this excess lint accumulation will need to be removed from the wood flooring members to prevent moisture presence and further fungal growth. (PHOTO PAGE 13a)

Excessive dryer lint located in crawlspace interior

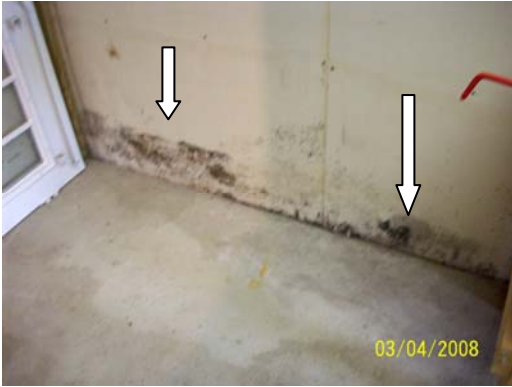
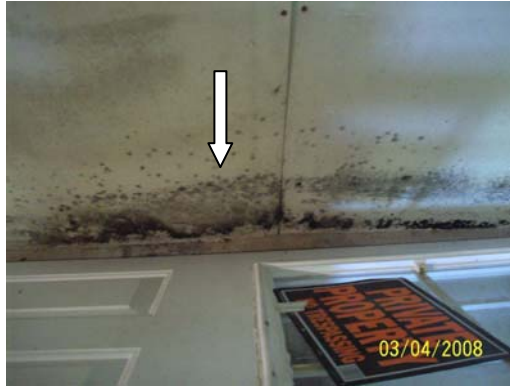
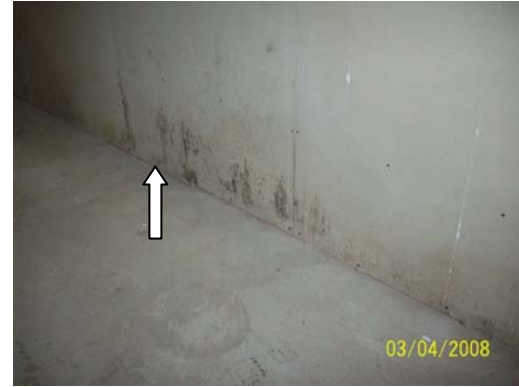
1. Interior wall board showing evidence of heavy fungal growth, all fungal affected interior wall board will need to be removed and replaced. (PHOTO PAGE 14a)

Detached garage interior wall board with heavy fungal growth

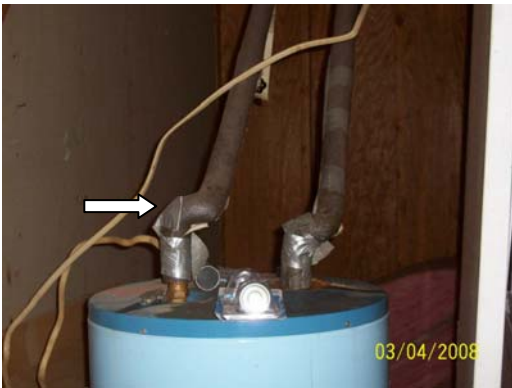
2. Copper water supply line located at electric water heating unit leaking and will need to be repaired by a licensed plumbing contractor to restore heating unit function. (PHOTO PAGE 14a)

Leaking hot water supply line

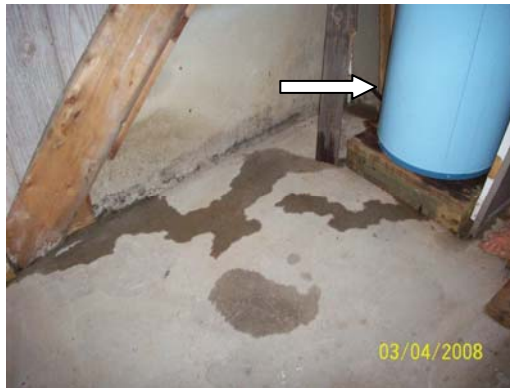
3. Electric water heating unit not inspected due to leaking condition, unit is approximately 13 years of age and is at the end of its typical service life. After completed plumbing repairs unit will need to be further evaluated to determine functional ability. (PHOTO PAGE 14a)

Water heating unit 13 years old

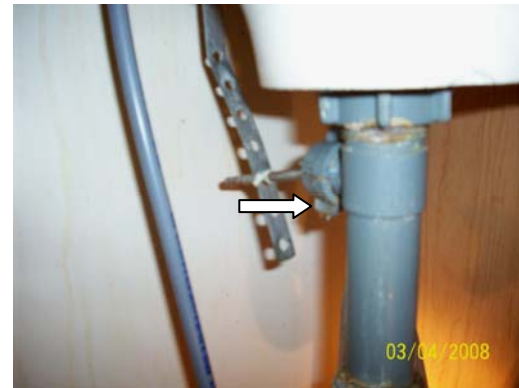
4. Detached garage upper level bathroom sink basin showing evidence of leakage at the drainage line drain stopper fitting, leaking waste line will need to be further evaluated and repaired by a licensed plumbing contractor. (PHOTO PAGE 14a)

Detached garage sink basin with leaking drainage pipe

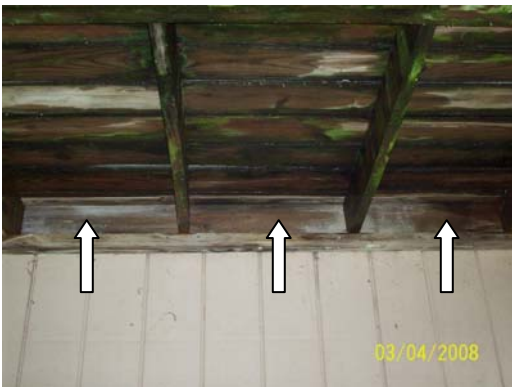
5. Rear exterior wood deck showing evidence of uninstalled lag bolts or lag screws, this missing hardware will need to be installed on the ledger board and fastened to the floor joists to provide additional support to the deck structure. (PHOTO PAGE 14 a)

Rear wood deck with uninstalled lag screw hardware

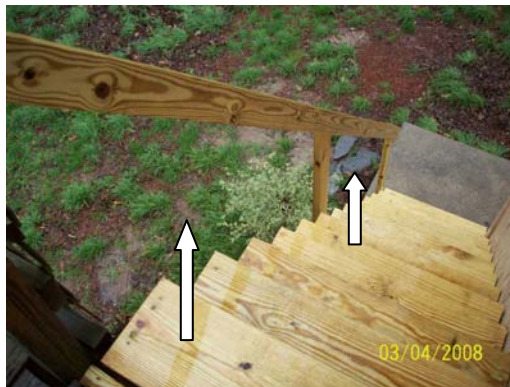
6. Detached garage rear stairwell showing evidence of missing vertical balusters, these missing balusters are in need of immediate installation to prevent possible injury to small children and as a safety concern. (PHOTO PAGE 14a)

Rear wood deck stairwell hand railing with improper vertical balusters

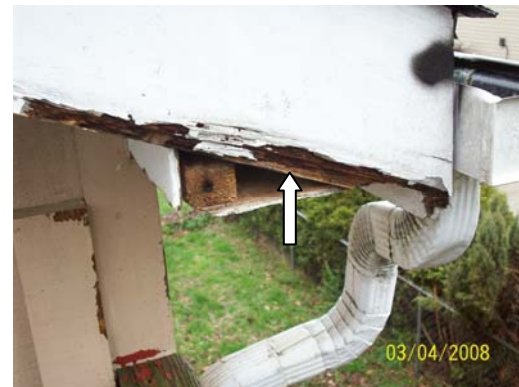
7. Detached garage wood trim showing evidence of numerous areas of rot and deterioration, all deteriorated wood components will need to be removed and replaced with new wood caulked and painted to reduce further deterioration. (PHOTO PAGE 14a & b)

Wood fascia trim with rot and deterioration

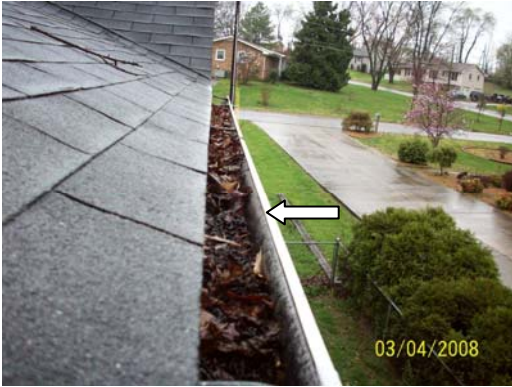
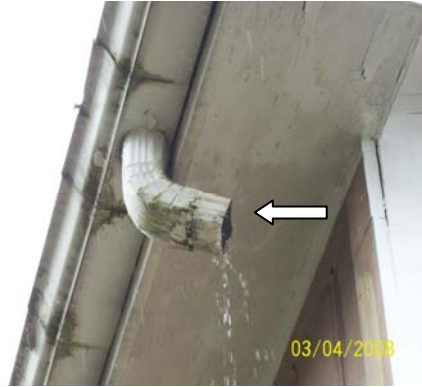
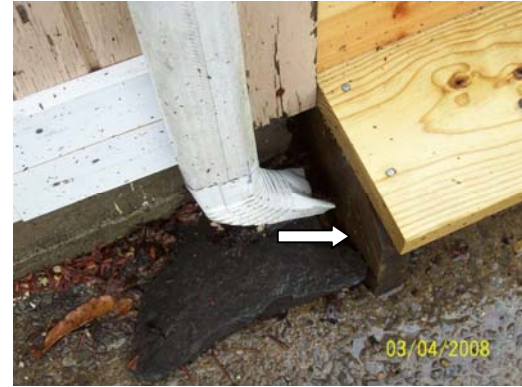
8. Detached garage guttering components showing evidence of damage, improper drainage and excess leaf debris. All damaged guttering components will need to be repaired or replaced by a licensed guttering contractor to allow for proper roof drainage. (PHOTO PAGE 14b)

Detached garage with clogged, missing and improperly draining gutters and downspouts

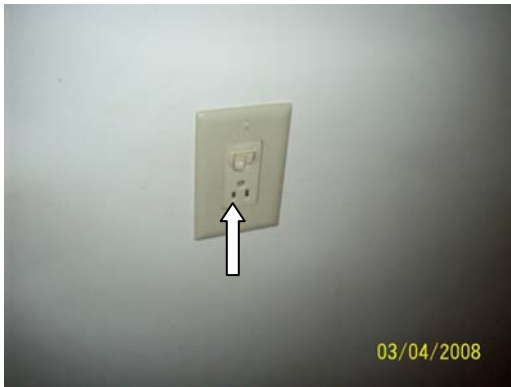
9. Detached garage upper level bathroom electrical switch plate showing evidence of a non _____
functioning receptacle and in need of repair or replacement by a licensed electrical contractor. _____
(PHOTO PAGE 14b) _____

Detached garage electrical receptacle not functional

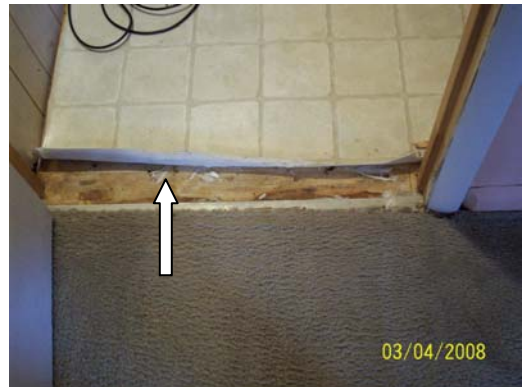
10. Upper level vinyl floor covering showing evidence of deterioration and will need to be removed __
and replaced to reduce the risk of tripping hazard. (PHOTO PAGE 14b) _____

Detached garage upper level with damaged vinyl floor covering

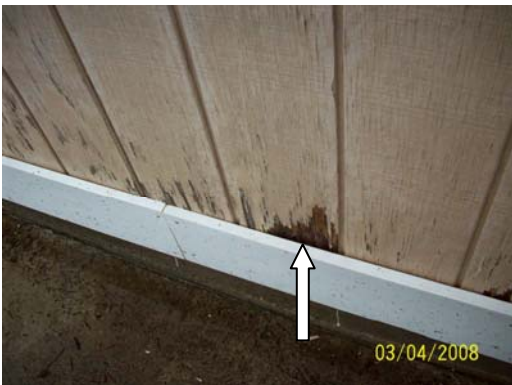
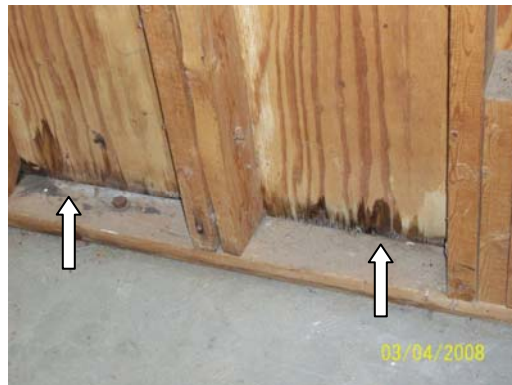
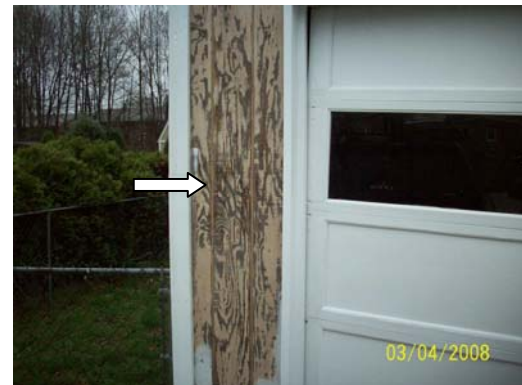
Detached garage wood siding with water penetration and peeling paint
